## PIC24FJ64GA004 Family Silicon Errata and Data Sheet Clarification

The PIC24FJ64GA004 family devices that you have received conform functionally to the current Device Data Sheet (DS39881D), except for the anomalies described in this document.

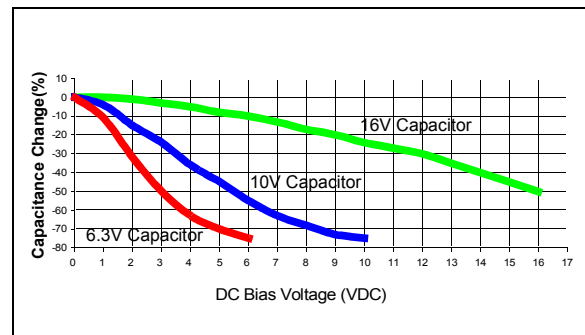
**FIGURE 2-4 DC BIAS VOLTAGE vs. CAPACITANCE CHARACTERISTICS**

A typical DC bias voltage vs. capacitance graph for 16V, 10V and 6.3V rated capacitors is shown in Figure 2-4.

When selecting a ceramic capacitor to be used with the internal voltage regulator, it is suggested to select a high-voltage rating, so that the operating voltage is a small percentage of the maximum rated capacitor voltage. For example, choose a ceramic capacitor rated at 16V for the 2.5V core voltage. Suggested capacitors are shown in Table 2-1.
